INACTIVE AND ABANDONED MINE LANDS— Apex Mine, Money Creek Mining District, King County, Washington

WASHINGTON
DIVISION OF GEOLOGY
AND EARTH RESOURCES

Open File Report 2001-2
December 2001

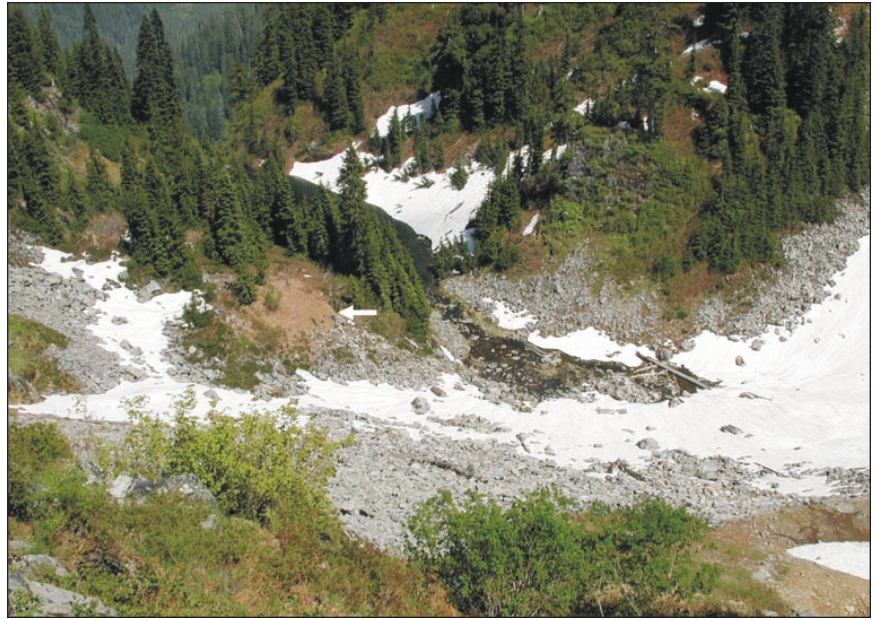
Figure 2. (top) View from adit 2 looking northeast. White arrow points to former location of higher camp.

company constructed a rock house, snow shed, and bunkhouse for 30 men at the upper tram terminal (DGER mine file). Another, higher, camp was located on the west shore of a small lake (unnamed) in a basin below adits 2 and 3 (Fig. 2).

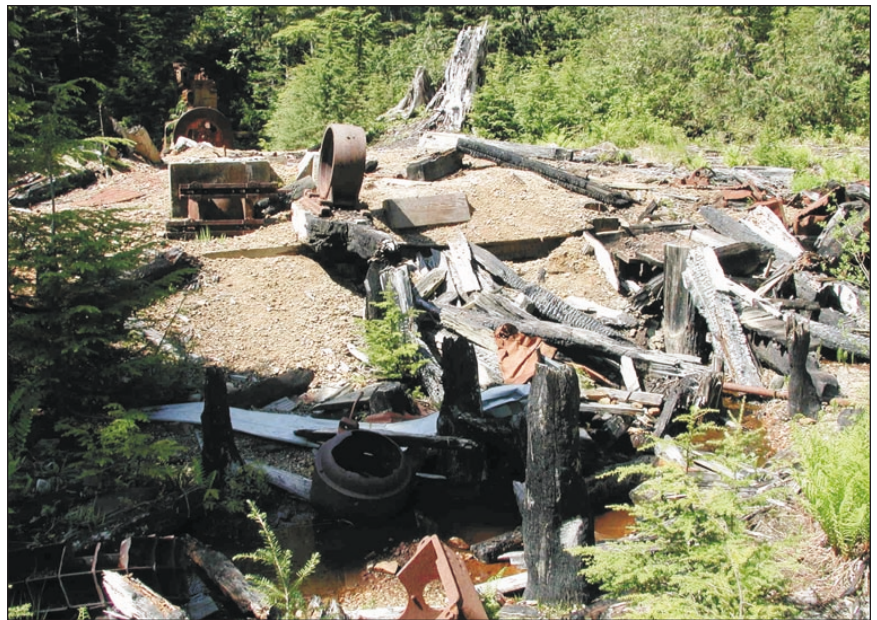
Figure 3. (middle) Site of lower tram terminal and mill. The diesel engine is in the top left corner of the photo.

We visited the site on 29 June 2001. All the structures described above have burned or collapsed due to decay and snow load. A stationary diesel engine remains upright at the lower tram terminal amidst cast iron housings from electrical power equipment and miscellaneous scrap iron (Fig. 3). Mining-related machinery/equipment remaining on site is limited to a steel culvert that had been used as a bunkhouse and salvaged rail at the portal of adit 4 (Fig. 4).

Machinery: A 150-horsepower diesel engine stands on footings at the lower tram terminal. It is rusted and stripped of component parts (online photo 1596). A generator housing, Pelton water wheel, and assorted cast iron relics lay scattered around the engine (Fig. 3, online photo 1595).

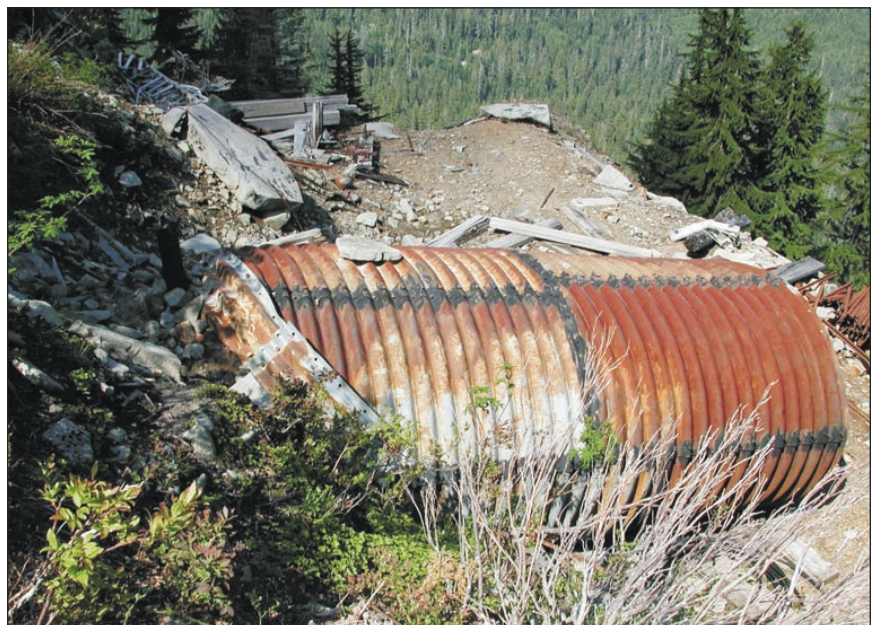
Figure 4. (bottom) Site of the upper tram terminal and bunkhouse (in culvert). Note the scrap haulage track at the far right center.

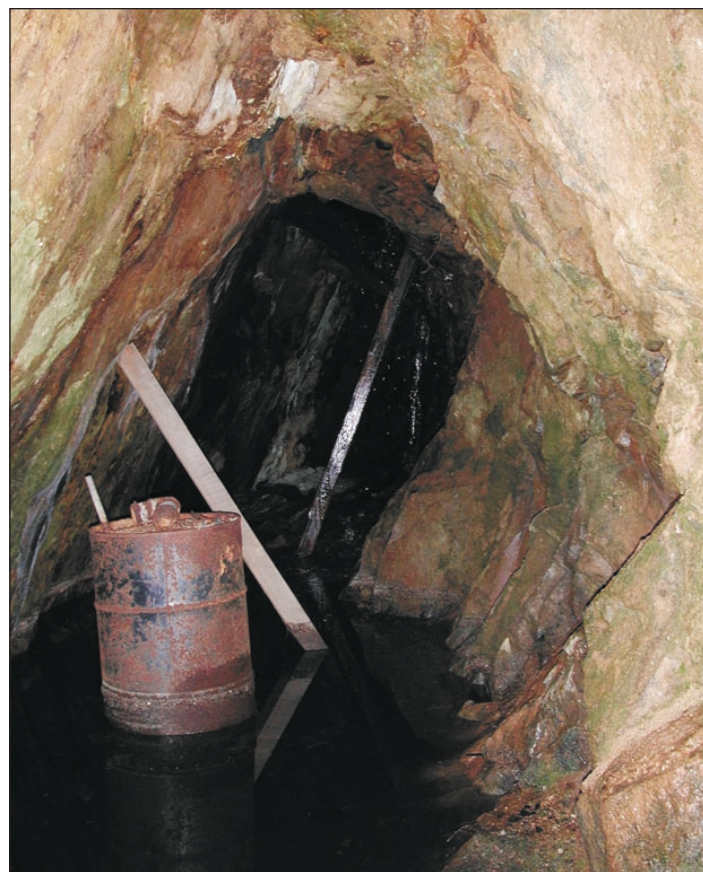
Adit 2, the highest mine working investigated, is open and appears sound. It is located directly on the vein centerline at an elevation of 3940 feet. Water from a ravine pours into the tunnel from an opening 25 feet inside the portal, creating a pool of standing water on the floor. There was no discharge to the surface at the time of site visitation. A 55-gallon drum of unknown material stands just inside the adit (Fig. 5). Adit 3, at 3800-foot elevation, is partially caved. Adit 4 is located in the vertical-walled canyon of Milwaukee Creek, which is the outlet of the unnamed lake. The original portal to adit 4 lies to the left of a snowfield, directly above cribbing holding the

Figure 5. Adit 2 entrance, elevation 3940 feet. Note the rusted barrel and the standing water on the floor.

Materials: A rusted 55-gallon drum stands in 10 inches of water on the floor of adit 2 at the portal. Its contents are unknown (online photo 1599).

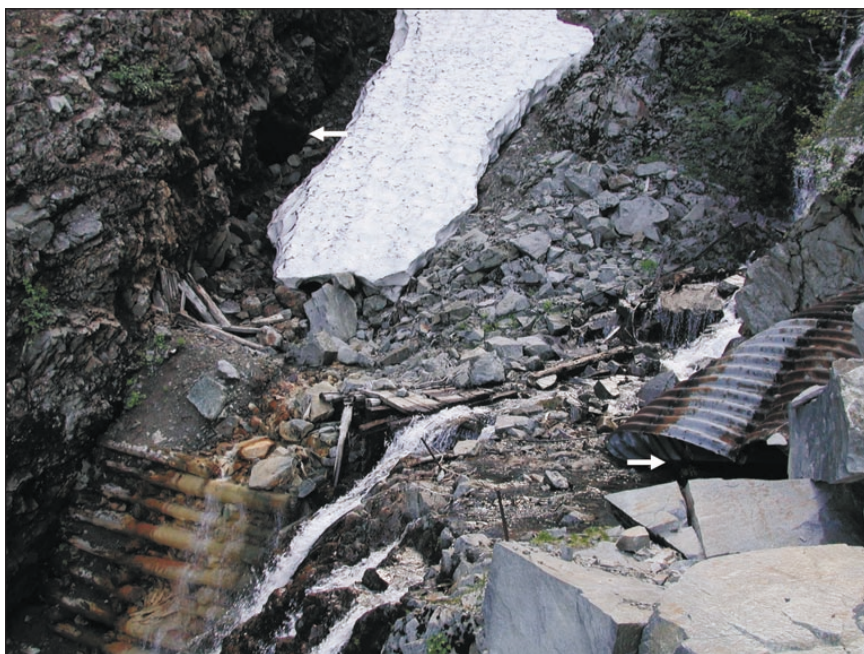
landing in place (Fig. 6). The steel culvert in the photo lies at the same elevation, in front of a snub-tunnel, circa 1980, driven into the right-hand side of the canyon for 20 feet. It appears to double back to the southeast to intersect the original tunnel.

A granite slab overlying the portal of the snub-tunnel near adit 4 has crushed the culvert insert. Detritus overlying the portal of adit 3 is supported by two-inch lagging of questionable strength (Fig. 7). Conditions underground are unknown, but considered hazardous by default. The area surrounding the mine is precipitous mountain terrain, especially the chasm formed by Milwaukee Creek below the lake. Traverses demand appropriate attention and care.

Figure 6. Area of adit 4 showing original opening location (left arrow) and portal of snub tunnel (right arrow). Milwaukee Creek (outlet) flows through photo.

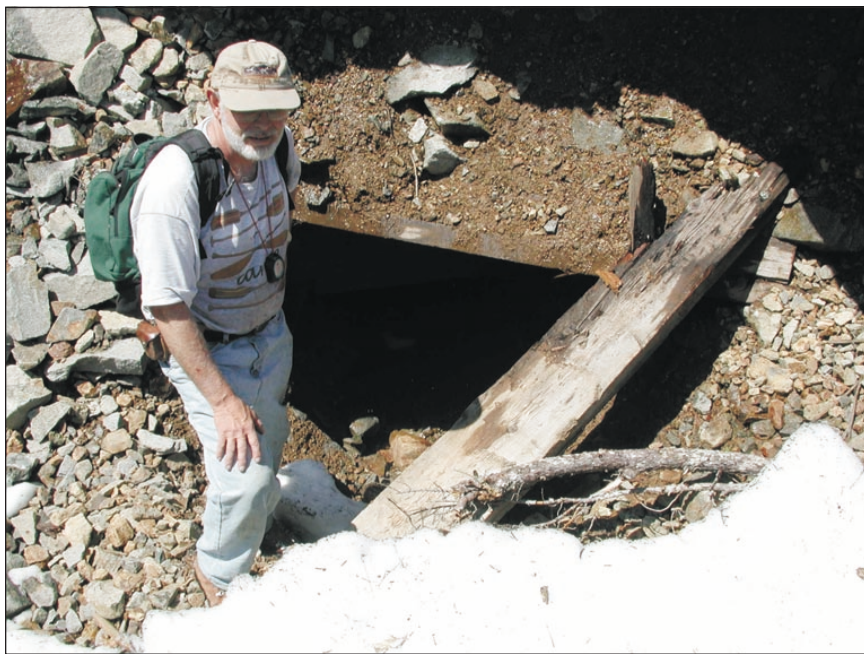
Figure 7. DGER geologist at portal of adit 3, elevation 3800 feet.

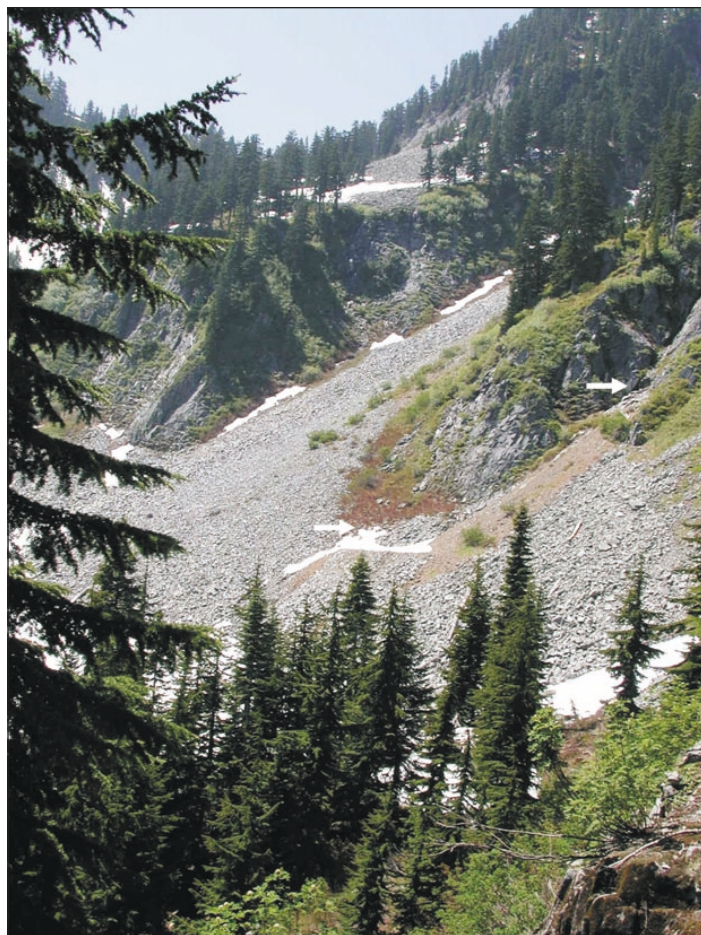
Figure 8. Looking south toward adits 2 (upper arrow) and 3 (lower arrow), elevation 3800 feet.

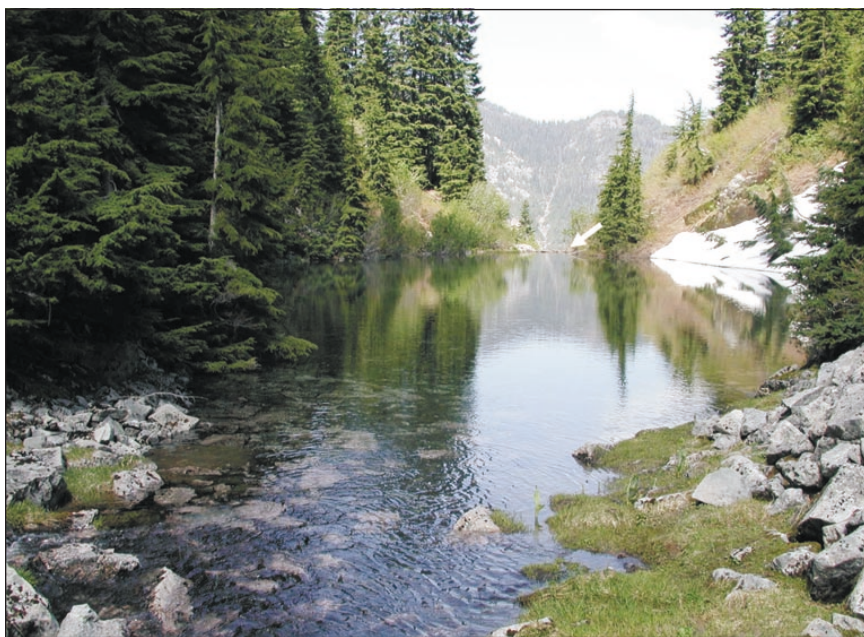
Figure 9. Looking north at the unnamed lake in the basin below adits 2 and 3. Adit 4 lies 200 feet beneath the outlet (white arrow).

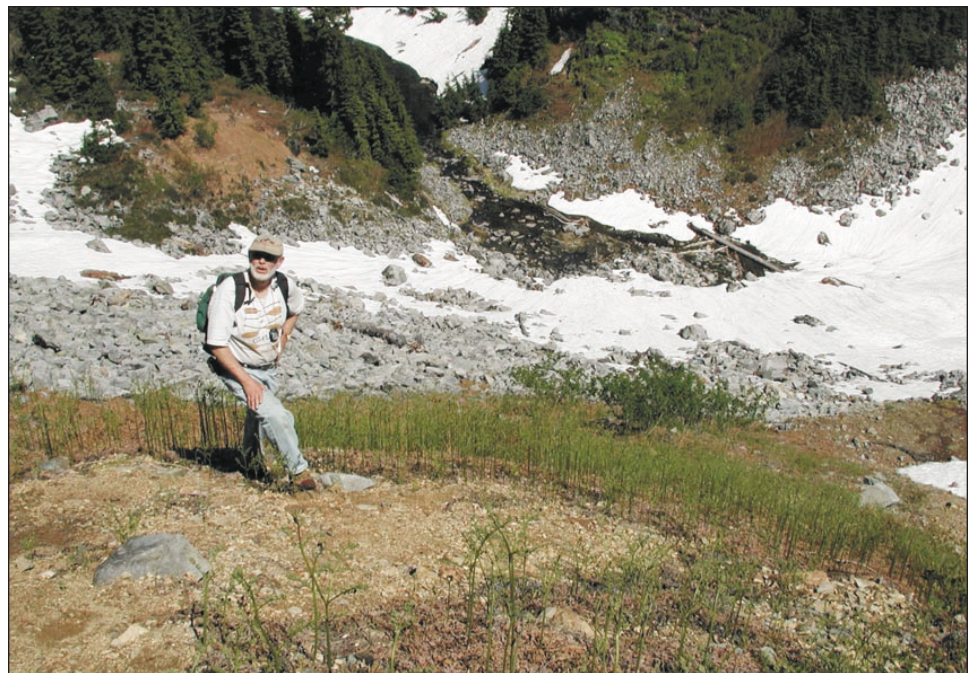
The mine dumps are barren of vegetation, the one exception being material from adit 2 at elevation 3940. It supports a thick stand of bracken fern, and isolated clumps of mountain ash (Fig. 10). Flora on the remaining mine land resembles typical Cascade Montane Forest Zone assemblage of wildflowers and plants—slide alder, low bush blueberry, alpine fir, Douglas fir, red cedar, western hemlock; avalanche lily, bleeding heart, buttercup, fringe gentian, paint brush, fan-leaf cinquefoil, and green false hellebore.

**Figure 10.** DGER geologist stands on the adit 2 dump, which is covered with bracken fern and mountain ash.**Table 3.** Surface water field data. ---, no data; *, numbered photos online at <http://www.wa.gov/dnr/htdocs/ger/iaml/01-2/>
